Railway ballast degradation

Conference paper STRC 2015

15th Swiss Transport Research Conference
Monte Verità / Ascona, April 15-17, 2015

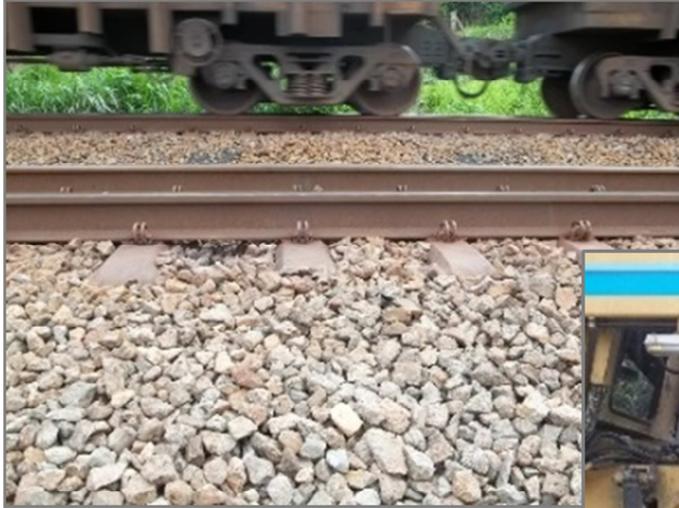
Figure 1 Contribution of processes to ballast degradation according to data from USA (a) and UK (b).

Ballast layer contamination is caused by different mechanical and environmental phenomena such as grain degradation, fine material pumping, external input (i.e. wagons material), sleeper/grain abrasion, weathering, etc. According to Selig & Waters (1994), data from the UK showed that the main source of contamination was external input (52%) and grain damage including tamping actions (41%). However, US data indicate that the most important source of fouling is grain breakdown (76%) including damage related to traffic, maintenance, weathering and general stresses (Figure 1). In general, the values presented show the significance of the amount of fouling material resulting from ballast grain degradation due to traffic and maintenance actions. Moreover, studies conducted by the Association of American Railroads (AAR) using petrographic analysis indicated that 75-90% of the fouling material accumulated during 300 million gross tonnes (MGT) was from ballast breakdown, and the remainder, from external sources.

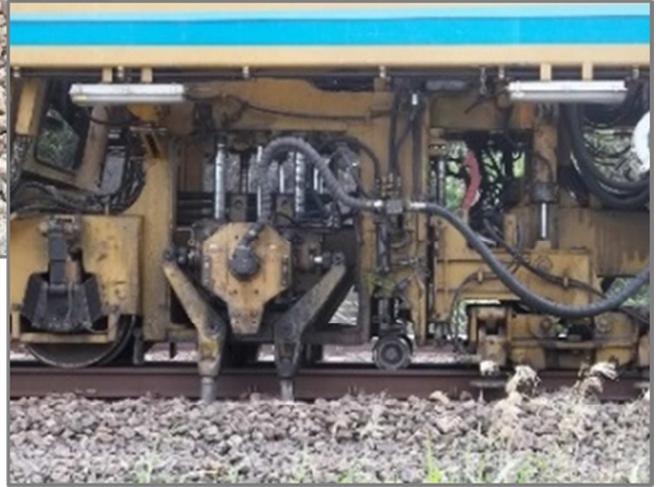
Figure 2 Examples of ballast degradation by wear (a) and breakage (b).

Ballast particles degradation can be understood as grain crushing in terms of breakage and abrasion and is a decisive factor in ballast behaviour (Indraratna et al., 1998). According to Lekarp et al. (2000), crushing is a progressive process starting at relatively low stresses and results in gradual changes in granular fabric and packing. According to Terzaghi & Peck (1962), the mechanism of rockfill compression is the result of the crushing of highly stressed contact points and particles rearrangement during load application. A similar mechanism is expected to develop in railway ballast at contact points.

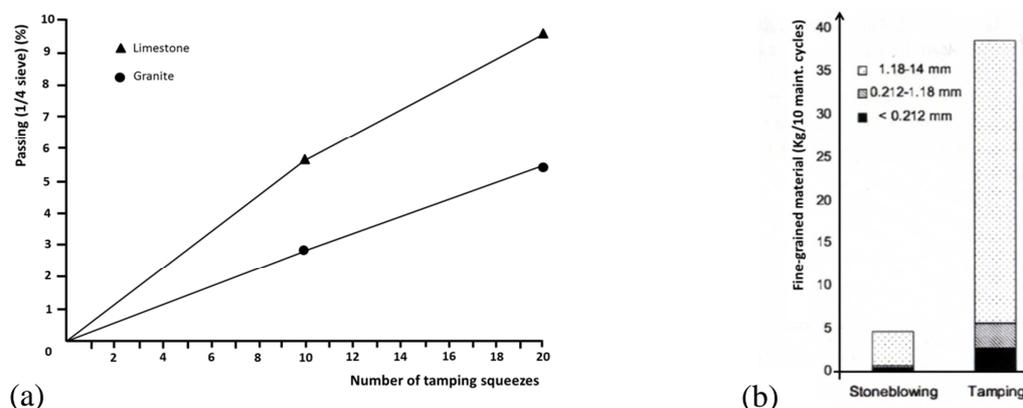
Figure 3 Fine material amount produced by number of tampings for different ballast materials (a) and different maintenance techniques (b).

A study carried out by AAR (1990) through a series of in-track tests showed the tamping significance on the fine material ($\leq 1/4''$ sieve) generation after 10 and 20 tamping's (Figure 3a). Results showed an almost linear relationship between the number of tamping's and the fine material amount and a production of between 0.45-0.9 Kg of fouling per squeeze. Similar results concerning the linear trend between fouling material generation and number of tamping actions were also found by Rothlisberger (2000) and Aursudkij (2007). According to the latter author, unlike what occurred with ballast material during tines insertion, material from the squeezing region was not influenced by the number of tamping's.

Zarembski & Newman (2008) reported data comparing ballast degradation at both tamping and stone blowing maintenance methods (Figure 3b). The results revealed that a much larger amount of fine material originated from the tamping with a production of approximately 4 Kg per action. These rates are similar to those found on UK railways (Selig & Waters, 1994).

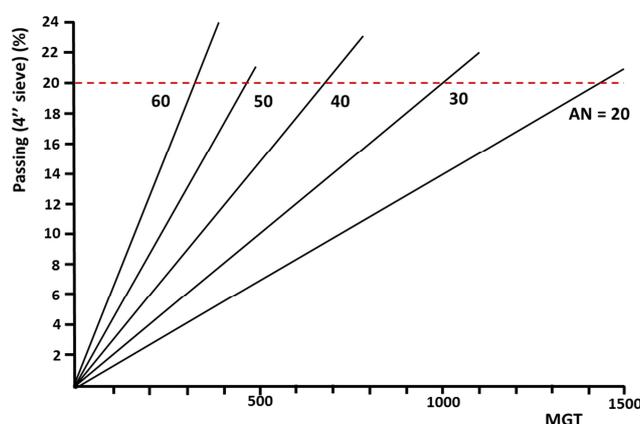
Figure 4 Example of ballast fouling related to quality and MGT value.

AAR (1989) performed a study of degradation rates related to ballast quality in terms of Abrasion Number (AN=LAA+5MA) and MGT value. The results showed a clear difference in ballast fouling between ballast materials with different abrasion values (Figure 4).

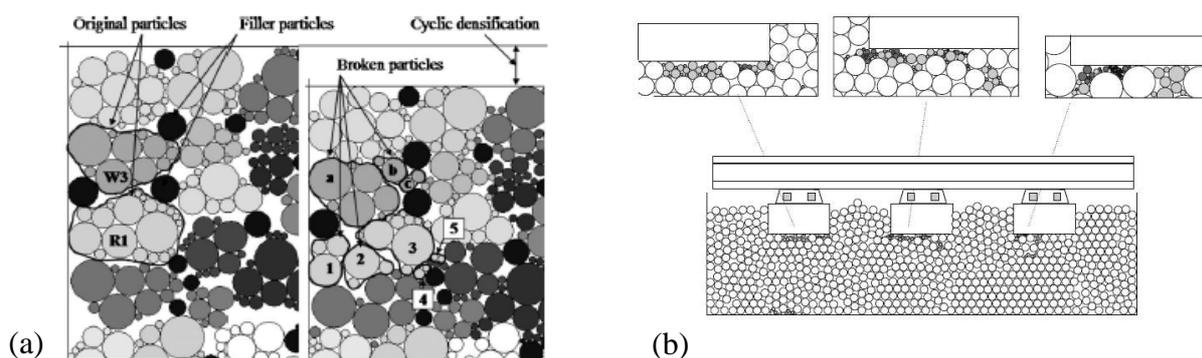
Figure 5 Portion of assembly showing particle breakage (a) and detail of crushable ballast representation (b).

In order to represent particle breakage, several methods have been used as for example, the replacement of particles fulfilling a predefined failure criterion with an equivalent particle group and the consideration of each particle as porous agglomerate built by bonding smaller particles. Figure 5(a) and 5(b) shows examples of ballast grains models according to Indraratna et al. (2010) and Lobo-Guerrero & Vallejo (2005) respectively.

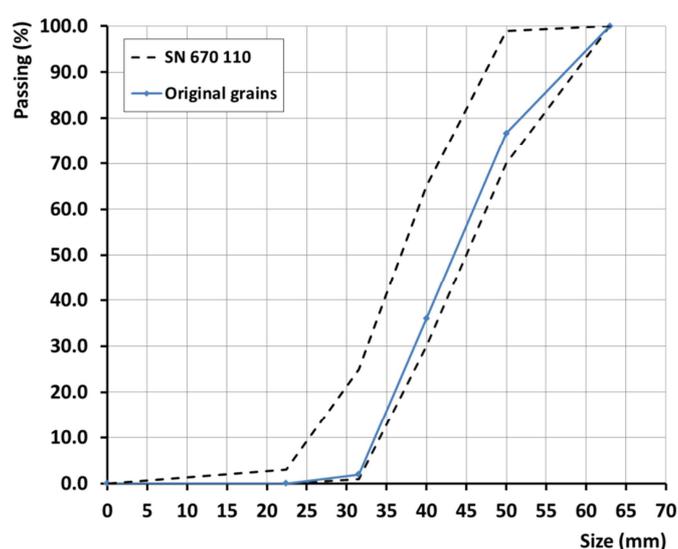
Figure 6 Granulometric curve of studied ballast material.

The material studied in both analyses was sandstone ballast with 25-30% of hard minerals, with a particle size of between 22.4 and 63.0 mm and LAA values of between 11 and 15 complying with EN 13450, collected from a quarry that supplies material for the Swiss Federal Railways (CFF/SBB). Figure 6 shows the granulometric curve of the studied material while Table 1 shows some material characteristics comparing them with the values prescribed by Swiss Standard SN 670 110 (Rothlisberger, 2009).

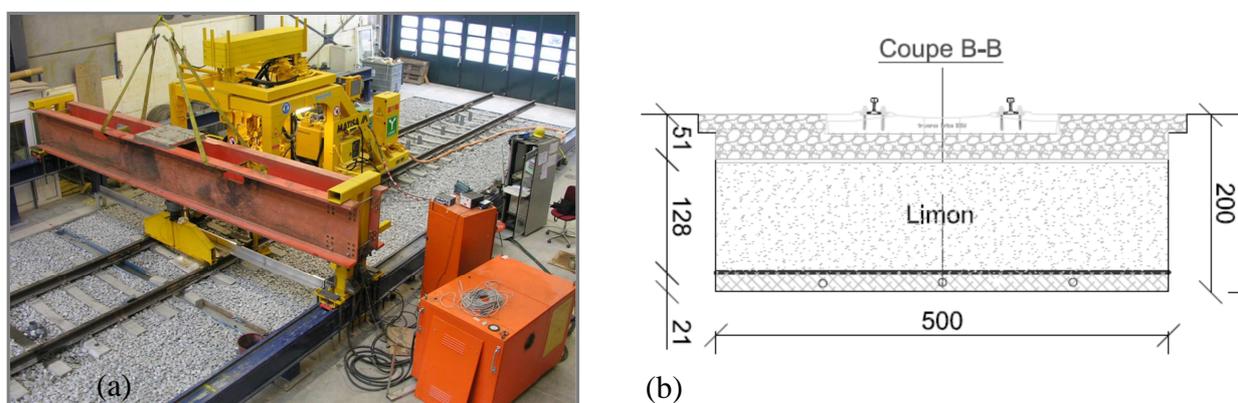
Figure 7 General view of test pit test with the beam for load application (a) and infrastructure profile (b).

In the second study, data from Paderno (2010) with the same material were used for ballast degradation evaluation. The data were obtained from a large scale apparatus constructed *ad hoc* to simulate traffic and tamping procedures using a static-dynamic cylinder and a real-scale tamper machine respectively. Figures 7(a) and 7(b) shows the test pit used with the beam for load application and the infrastructure profile installed.

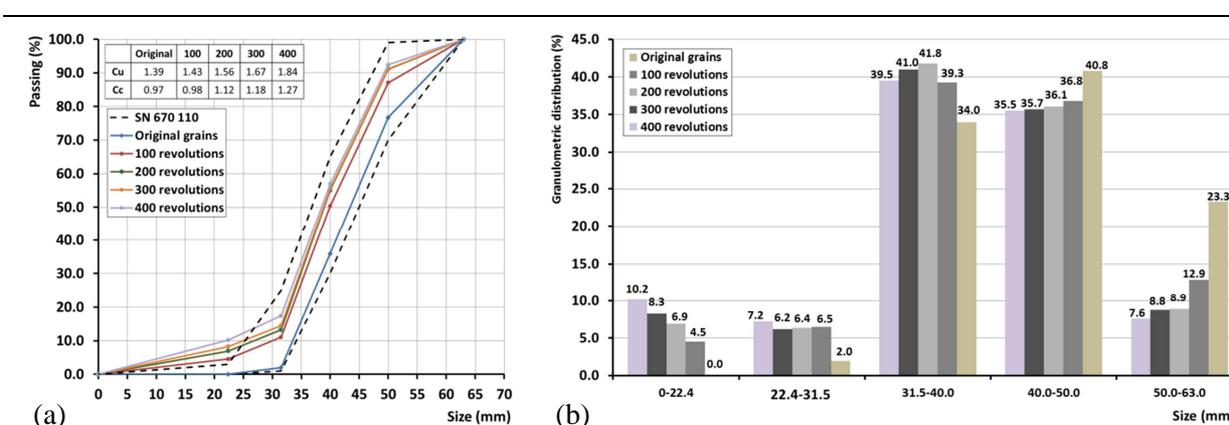
Figure 8 Granulometric curves and grading factors (a) and granular fractions distribution (b) of tested ballast material.

As described, the granulometric curves over the revolution stages were obtained from the LAA tests performed. Figure 8 (a) and (b) shows respectively these curves with the values of Cc and Cu and the granulometric distribution variation at the granular fractions studied.

Figure 8 shows that after 100 cycles all the granular fractions were affected by the degradation and the fraction between 0-22.4 already failed to comply with Swiss Standard (SN 670 110) since that the maximum allowed for this fraction is 3% but just after 100 cycles, the value was approximately 4.5%. In the subsequent revolutions, the observed granulometry deviation was lower with a larger increasing and decreasing trend for the 0-22.4 and 50.0-63.0 mm fractions respectively.

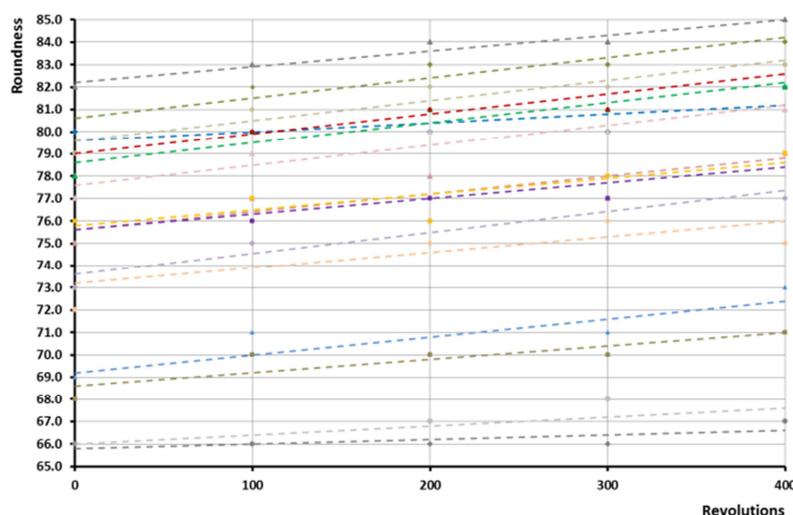
Figure 10 Roundness increase for some grains tested through the revolution stages.

In the tests performed, wear degradation was characterised by a progressive and more or less linear increase of the roundness value calculated. Figure 9 shows an example of a grain wear degradation evolution over the revolution stages, while Figure 10 shows the calculated roundness value increase through the stages for some of the ballast grains tested.

Figure 9 shows a sequence related to the wear degradation evolution with no breakage and a rounding trend on its surface, while Figure 10 shows a smooth and approximately linear roundness increase along the revolutions. Generally, initial grain roundness varied from 57 to 83 with most of the grains having a value of between 70 and 80 and had an increase that varied by up to 5%.

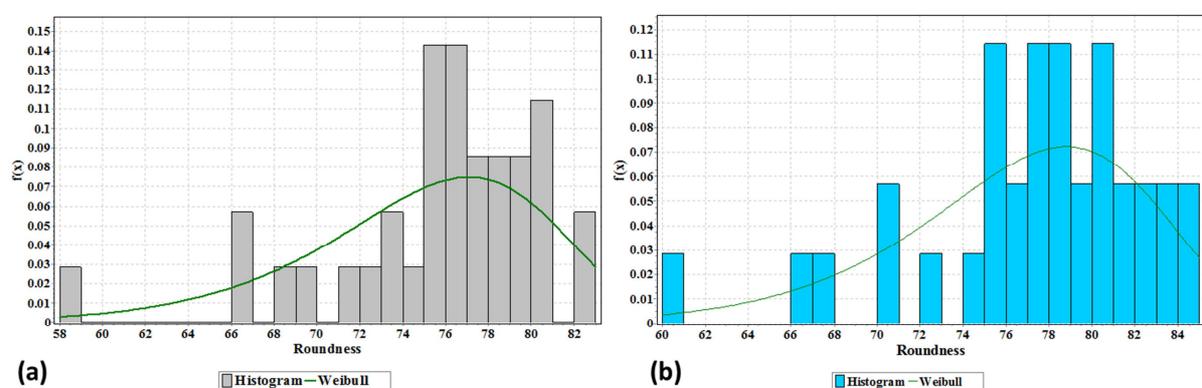
Figure 11 Histograms and Weibull distribution curves for roundness values obtained for original grains (a) and after 200 revolutions (b).

Figure 11 shows examples of histograms and Weibull curves for the roundness values found for grains tested before (original grains) and after 200 revolutions.

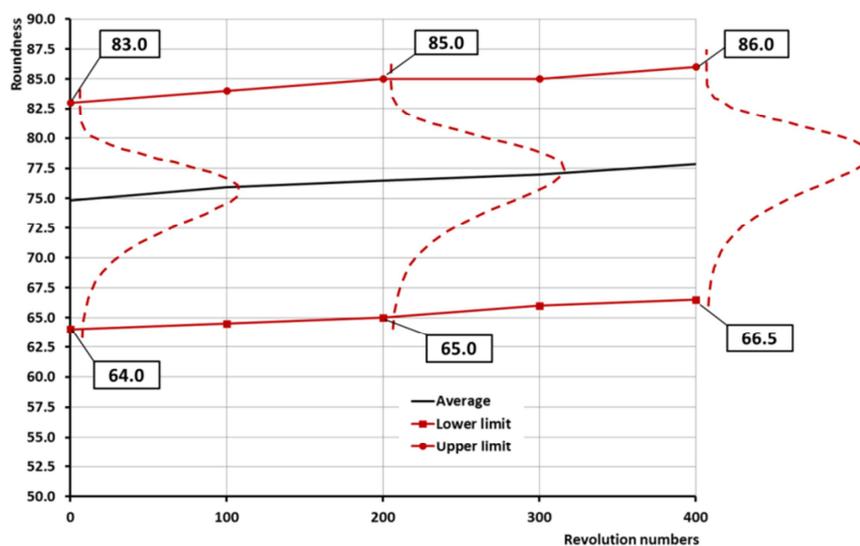
Figure 12 Confidence levels and average evolution within pdf through stages.

Figure 12 shows the variation of the average roundness and the confidence interval (90% of confidence) determined with the probability density function (pdf) according to the Weibull function considering the original grains and those after 200 and 400 revolutions.

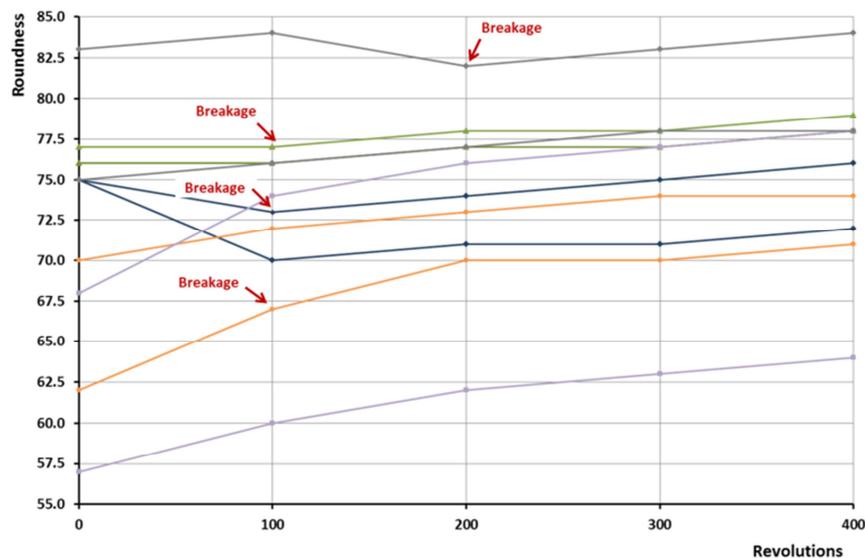
Figure 14 Roundness evolution in case of partial grain breakage with subsequent abrasion degradation trend.

It can also be seen that for some grains that suffered partial breakage, there was just a slight deviation in the roundness value while for others, breakage produced an important change in the roundness as this breakage can impose relevant modifications in grain shape that in some cases resulted in different roundness magnitudes.

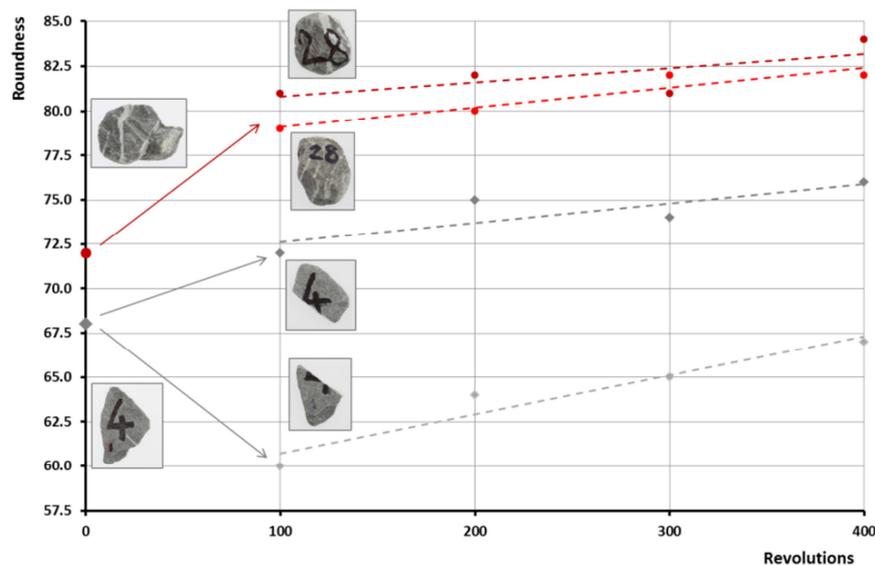
Figure 15 Roundness evolutions with complete grain breakage with subsequent abrasion trend.

Still related to the breakage phenomenon, some grains suffered a full breakage characterised by a clear grain division into approximately two similarly sized parts in the first stages. Subsequently, the two new grains followed the wear degradation trend with a new roundness value and a very low mass loss and roundness value increase. Figure 15 shows the roundness variation in two grains related to this degradation mode over the revolution stages.

As shown in the wear degradation mode, in breakage degradation case there was also a good linear correlation (average of 0.76) between the increase of the roundness value and the revolution number.

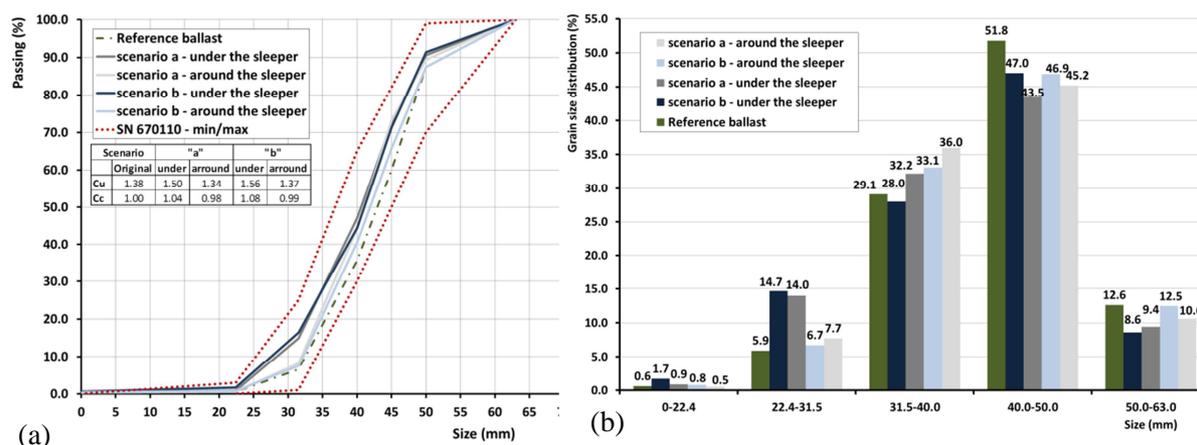
Figure 16 Granulometric curve (a) and distribution (b) of ballast grains for different scenarios and at different collection points.

From the full-scale tests performed to simulate traffic and maintenance conditions, ballast material samples were collected at different places after simulations related to the scenarios *a* and *b* presented above. Figure 16 (a) and (b) shows respectively the granulometric curves and distribution variations (Paderno, 2010).

From Figure 16, it can be seen that the characteristics of each scenario did not significantly influence degradation considering the same collection place and it therefore seemed to have a secondary influence. However, comparing the collection places, the data showed a clear difference especially regarding the higher percentage of grains in the fraction of 22.4-31.5 mm collected under the sleeper.

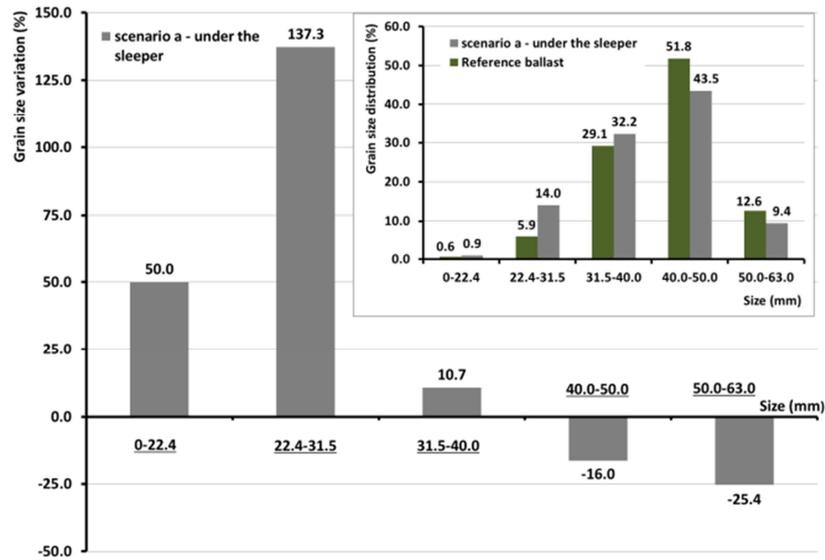
Figure 17 Grain size variation and distribution in samples collected under sleepers in scenario a.

22.4-31.5 mm that was significantly higher compared to the former case. Figures 17 and 18 show the grain size variation in both scenarios with the material collected under the sleeper.

From the figures, in both scenarios, it can be seen that the biggest granulometric increase was related to the granular fractions between 0-22.4 and 22.4-31.5mm, although these fractions are those containing the lowest amount of material (0.6 and 5.9% respectively). Even with a high increase (50 and 183% for scenarios *a* and *b*, respectively), the global amount of material in the fraction of 0-22.4 mm remains low but important due to the fact that basically this fraction is the one related to the fouling material that can lead to a loss of the general mechanical properties of the ballast layer.

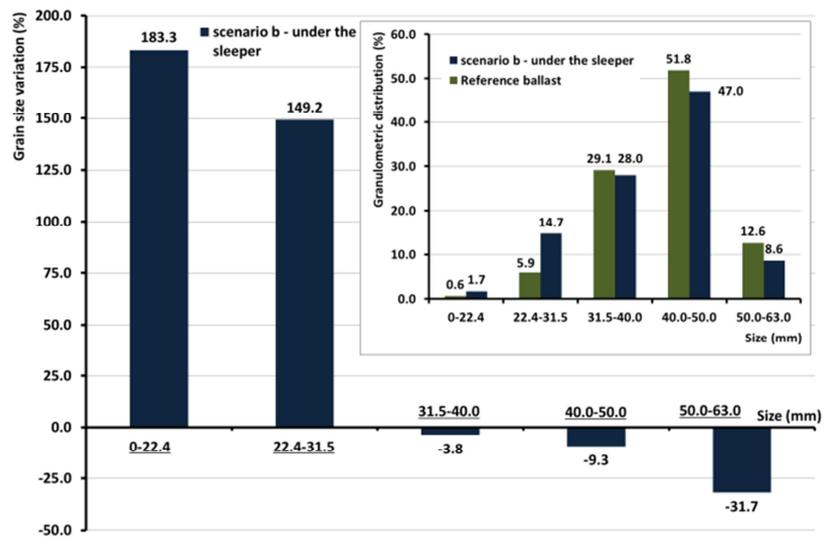
Figure 18 Grain size variation and distribution in samples collected under sleepers in scenario b.
